Quality Assurance and Source Inspection

Contract #: 04-0120F4Cty: SF/ALA Rte: 80 PM: 13.2/13.9File #: 69.28**WELDING INSPECTION REPORT****Resident Engineer:**Siegenthaler, Peter**Address:** 333 Burma Road**City:** Oakland, CA 94607**Report No:** WIR-021623**Date Inspected:** 25-Feb-2011**Project Name:** SAS Superstructure**OSM Arrival Time:** 700**Prime Contractor:** American Bridge/Fluor Enterprises, a JV**OSM Departure Time:** 1900**Contractor:** Zhenhua Port Machinery Company, Ltd (ZPMC), Changxing Island **Location:** Shanghai, China**CWI Name:** Lv Li Qing**CWI Present:** Yes No**Inspected CWI report:** Yes No N/A**Rod Oven in Use:** Yes No N/A**Electrode to specification:** Yes No N/A**Weld Procedures Followed:** Yes No N/A**Qualified Welders:** Yes No N/A**Verified Joint Fit-up:** Yes No N/A**Approved Drawings:** Yes No N/A**Approved WPS:** Yes No N/A**Delayed / Cancelled:** Yes No N/A**Bridge No:** 34-0006**Component:** OBG**Summary of Items Observed:**

OBG 14EAST

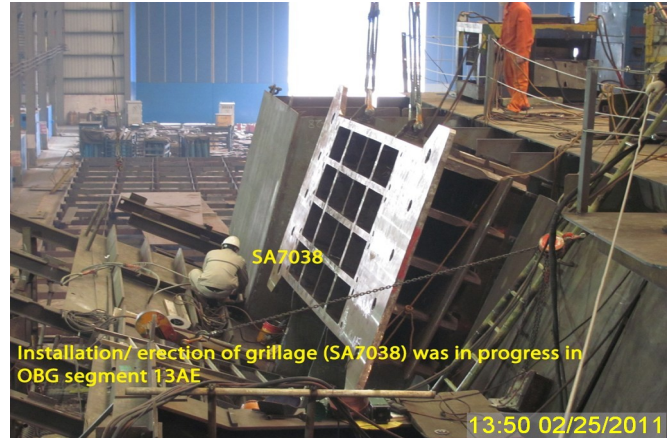
This QA Inspector observed installation/ erection of grillage (SA7038) was in progress in OBG segment 13AE See attached photo.
